**REPORT ON THE GEOTECHNICAL
INVESTIGATION OF THE
ROOIBERG LANDFILL SITE, LIMPOPO**

Client: LIMPOPO PROVINCE

Project No. JBC0798

Date: October 2012

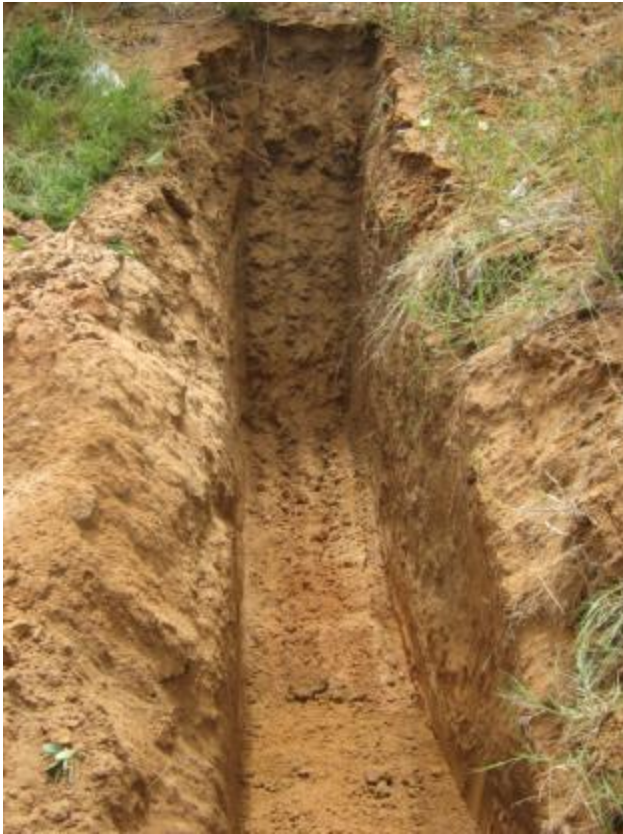
In general most of the test pits went to maximum reach (2.6m+) of the machine with partial refusal in RB TP 3 and 7 on weathered Quartzite. Although none of the test pit refused on the Ferricrete layer, Hardpan Ferricrete boulders are present in some of the test pits. However the Hardpan Ferricrete was brittle enough for the TLB to break through the layer.

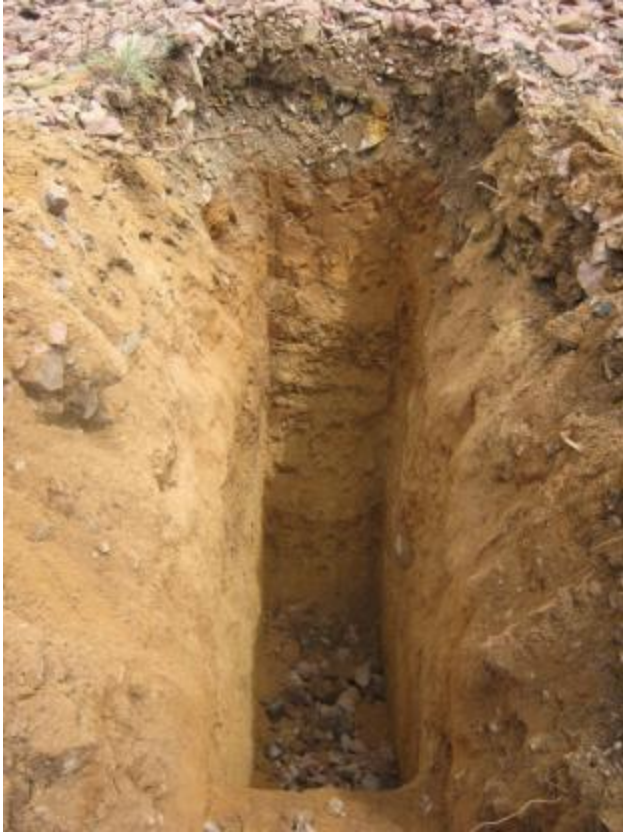
Rocky outcrops were also present on surface especially on the southern section of the site between RB TP 5 and 8.
